# Risk management: a case study of the wooden collection held in storage at the Folk Art Museum of Athens, Greece

## Abstract

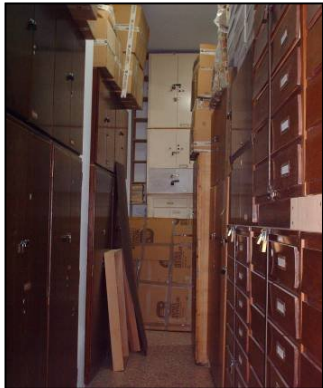
This storage facility is a former apartment on the ground floor of a three storey building located close to the Central Museum building. The facility was not purpose built but has been altered and developed to meet the museum's needs in order to house the movable collection. In recent years, the museum's policy of increasing acquisitions has led to the lack of proper arrangement of the artifacts and to overcrowding. Artifacts are stored in various locations, including on the floor, on top of cabinets and in the corridors (fig.1). The larger wooden

Figure 1- Overcrowding in the storage facility

In the first case, most are easily implemented, as these risks can easily be mitigated by introducing stricter procedures for the handling of artifacts and keeping records and labels made from appropriate materials. In this way, the physical forces and dissociation risk can be addressed with minimal financial investment. Extra storage space and adequate access can be provided in order to mitigate risks from overcrowding, by rearranging the storage facility and by conducting a stricter plan regarding the museums acquisition policy.

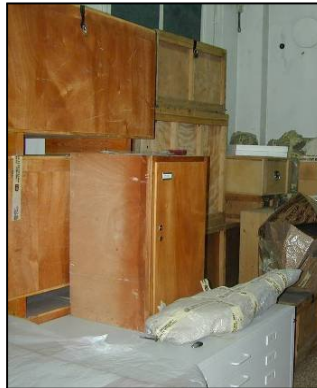
objects in the storage area (furniture, woodcarving, mirrors) have no protection whatsoever and lie directly on the floor, while smaller packaged objects are placed on top of wooden cupboards or structural elements of the building. For the packaging of much of the wooden collection, wooden and cardboard boxes, kraft paper or bubble wrap have been used (fig. 2). It had become clear to the Museum organization and personnel that the facility required reorganization in order to be safe and more accessible. Thus, the museum management initiated a systematic study to identify areas in need of improvement, through a risk assessment and re-evaluation of management processes. The goal was to develop a new layout that would work for the collection and for the staff, would be safe for both artifacts and personnel, meet their access needs and at the same time contribute to the preservation of the collection.

Figure 2-Packaging of wooden artefacts

Another risk that was characterized as catastrophic, regarding the action to be taken, is physical forces (PF5). This risk involves the damage caused to the artefacts that are stored in card boxes above the wooden cupboards and the structural elements of the building. It was calculated that 90% of the wooden collection is stored in this way. Bad placing and crowding of the artefacts, in conjunction with the lack of proper support, creates tension that could result in buckling or breakage of their most sensitive parts of objects. This fact, in combination with the constant growing number of objects and the poor handling and internal transport of objects used in temporary exhibitions, enhance the risk.

The long term improvements requiring further financing and planning could entail the replacement of the existing flammable fittings and packing material. For optimal protection from fire, the museum is encouraged to install an automatic suppression system and to create an active fire safety committee composed of staff and management. As far as the RH & T risk is concerned, in the absence of a full environmental control system, provided by a properly

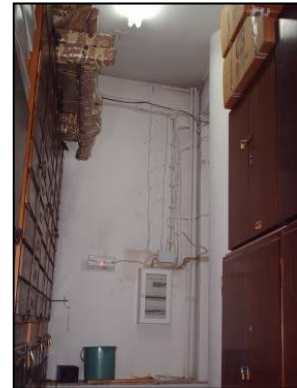
Figure 3- Faulty electrical board in the storage facility

The Risk Assessment results, presented in figure 4, showed that fire (F2) presented the highest risk for the wooden collection of M.EL.T. held in storage. The loss of the collection could be significant during a fire. The assessment indicates a high probability for fire to start in the storage area, due to the poor quality installation of electrical wiring in the building. A thorough examination identified a faulty electrical board on the wall between two wooden cupboards (fig.3). The heavy electrical load carried in this central electric supply, and the large number of individual cables within it, present an immediate and serious risk of fire. Given that there is a great amount of wooden material (artifacts, packaging material and equipment) close to it, the result could be catastrophic for the collection. The flammability of the materials inside the storage area could aid the spreading of the fire, with irreversible results. A fire alarm system does exist within the storage area, though there is the absence of an automatic fire suppression system. Thus, a fire could only be put out manually, using the extinguishers placed in a nearby room. Taking into account the degree of combustibility of material ignited, the density and the arrangement of the materials in the room (including both collection and non-collection items) and the size of the room, the scenario examined the possibility of fire reaching the flashover point, where the fire spreads from its source throughout the room, (Tétreault 2008).

As far as the fire risk is concerned, part of the solution can be addressed with immediate and low cost improvements, though part of the plan will require a more thorough financing programme. The biggest risk to the collection derives from the existing faulty electrical board. The solution is the replacement of that problematic installation and the removal of part of the electrical load, which should be redistributed equally to the three existing main supplies. In addition, more CO<sub>2</sub> fire extinguishers can be added in appropriate parts of the storage area to allow an immediate respond in case of fire, with staff fully trained in their proper use.
