CASE STUDY: ASSESSMENT OF THE MECHANICAL PROPERTIES OF AN OLD “PITCH PINE” TIMBER STRUCTURE.

Manuel C. TOUZA VÁZQUEZ*

*Centro de Innovación y Servicios Tecnológicos de la Madera (CIS-Madera), Spain.

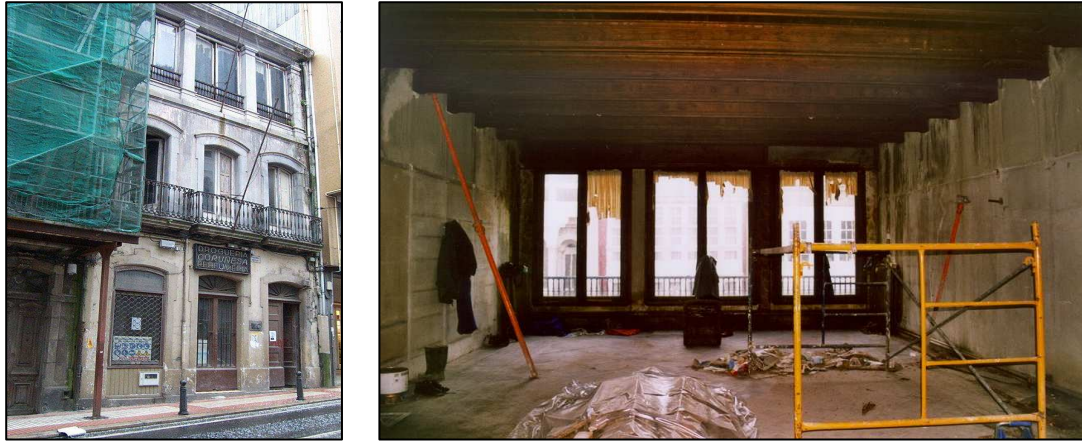
Figure 1. General view of the building and detail of a room where the beams are hidden inside artistic covers.

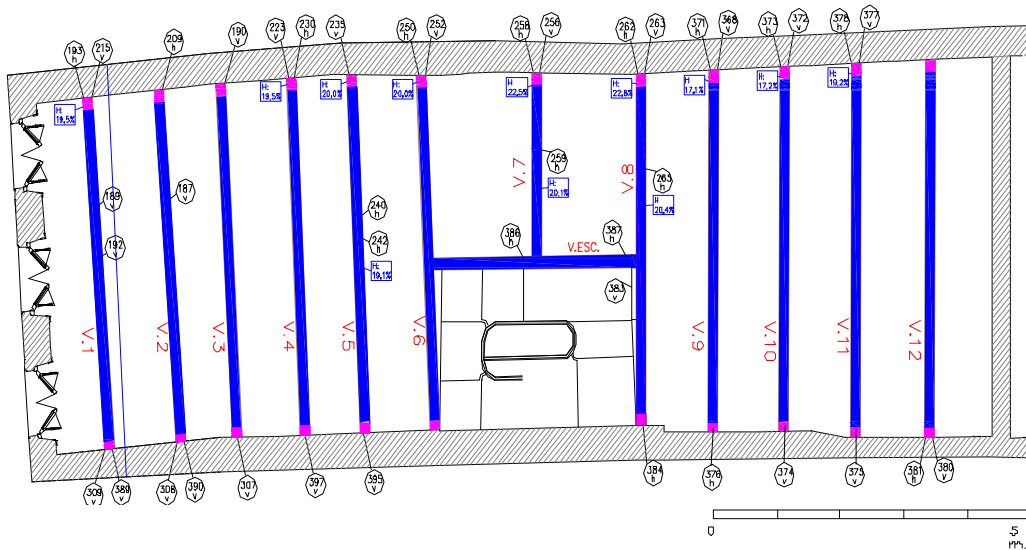
The timber floor structure above the first floor is formed by 12 main beams and all are in a good conservation state, so no interventions or repairs are needed due to biological degradation.

Figure 2 shows the plan of the timber floor structure above the first floor and summarize the results obtained with the resistograph. The blue color means a sound section of the timber and the pink one indicates a slight degradation. For each inspected beam, the numbers inside the circles identify the obtained profile if posterior consultations are needed.

Figure 2. Plan view of the timber floor structure above the first floor. Sound timber is represented by blue color while a pink tone indicates a slight degradation. Each obtained profile can be identified by the numbers inside the circle.

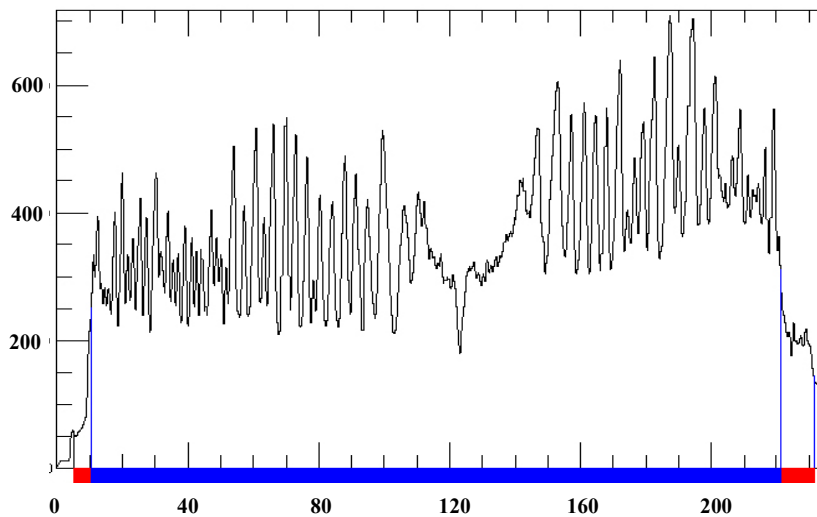
Figure 3 shows a resistograph profile obtained in a beam with a minimum portion of sapwood affected by biological degradation in their edges.

Figure 3. Resistograph profile obtained in the beam referenced as V-2 in the previous plan. The penetration depth (in mm) is reported on the x-axis, whilst the drill resistance is to be found on the y-axis. The effective section considered in the beam is marked in blue color.

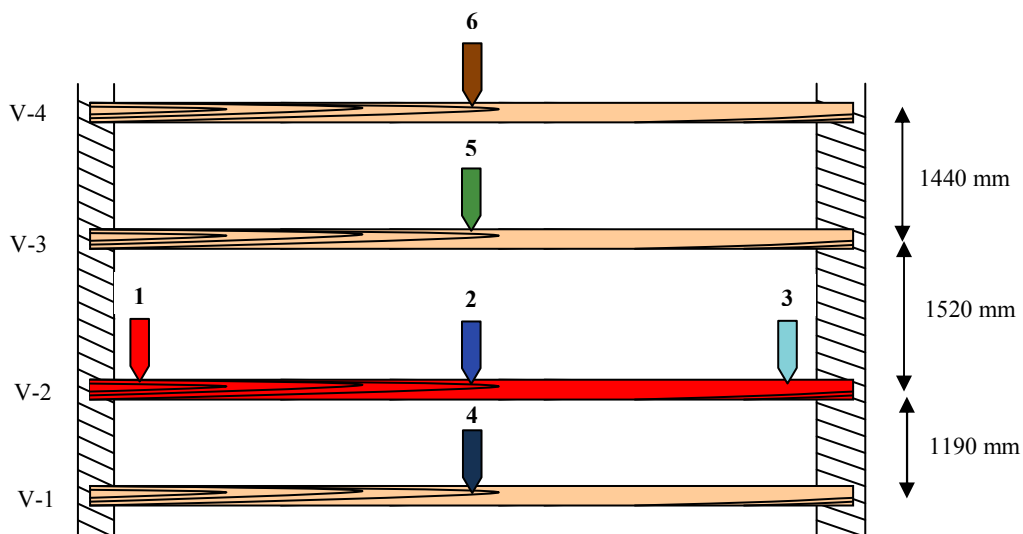
The deflection of each tested beam was measured with 3 indicators located at its center and edges. The deflection of the beside beams were also measured in order to understand the capacity of the structure to transmit the load and the real MoE of the tested beam. Figure 4 shows the distribution of the indicators during the test of the beam referenced as V-2 on the floor structure above the first floor.

Figure 4. Sketch with the distribution of the indicators during the test of the beam V-2.

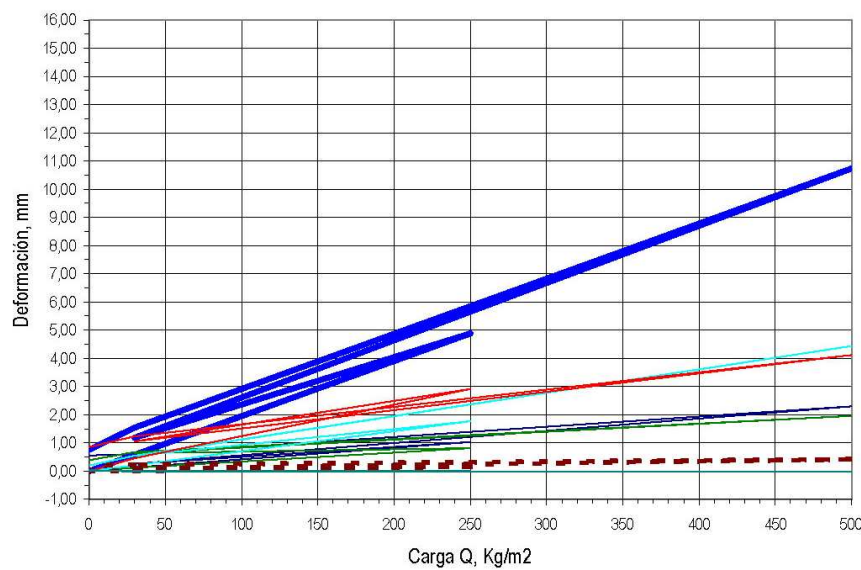
Figure 5 shows the measured deformations during the test of the beam V-2. The colours of the lines are the same previously used to reference the position of each indicator.

Figure 5. Deformations measured during the test of the beam V-2.

As for the mechanical properties, it could be obtained a medium MoE ($E_{0,mean}$) of 14,300 N/mm² for the tested beams. As reference, the Italian standard UNI 11119:2004 established a MoE of 13,000 N/mm² for the best quality of aged Italian pines [4]. Additionally, the resistograph profiles and some pieces of timber were also used to estimate the medium density ($\rho_{0,mean}$) of the beams in 700 kg/m³.

The obtained values of MoE and density may be considered very high for the genus *Pinus*. Both values, together with the minor singularities existing in the observed beams, were considered to propose a value of 30 N/mm² as characteristic bending strength ($f_{m,k}$) for the beams.

The imposed load specified by the TBC for variable actions in areas without obstacles for moving people as museums or exhibition rooms is 5 kN/m^2 and the deflection due to these actions is $L/350$ (user comforts) [5]. Both requirements were satisfied during the load tests.
