# Risk management: a case study of the wooden collection held in storage at the Folk Art Museum of Athens, Greece

## Abstract

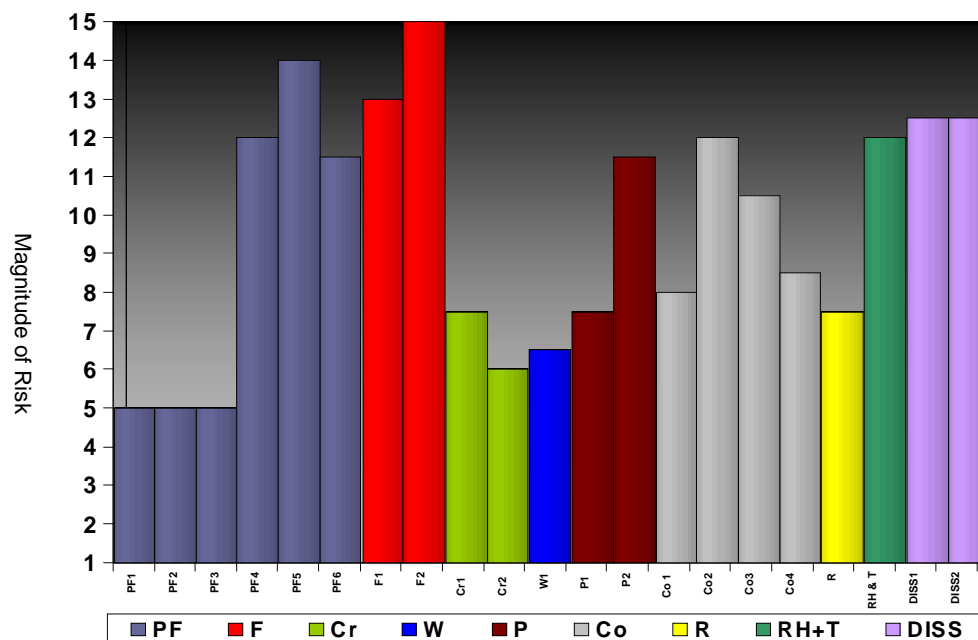
The Risk Assessment results, presented in figure 4, showed that fire (F2) presented the highest risk for the wooden collection of M.EL.T. held in storage. The loss of the collection could be significant during a fire. The assessment indicates a high probability for fire to start in the storage area, due to the poor quality installation of electrical wiring in the building. A thorough examination identified a faulty electrical board on the wall between two wooden cupboards (fig.3). The heavy electrical load carried in this central electric supply, and the large number of individual cables within it, present an immediate and serious risk of fire. Given that there is a great amount of wooden material (artifacts, packaging material and equipment) close to it, the result could be catastrophic for the collection. The flammability of the materials inside the storage area could aid the spreading of the fire, with irreversible results. A fire alarm system does exist within the storage area, though there is the absence of an automatic fire suppression system. Thus, a fire could only be put out manually, using the extinguishers placed in a nearby room. Taking into account the degree of combustibility of material ignited, the density and the arrangement of the materials in the room (including both collection and non-collection items) and the size of the room, the scenario examined the possibility of fire reaching the flashover point, where the fire spreads from its source throughout the room, (Tétreault 2008).

Figure 1- All MR values, as estimated by the 21 scenarios (MR values on the y-axis, specific risks on x-axis)
